CHT QUARRY (MOTA ULUN)  
ENVIRONMENTAL IMPACT STATEMENT  
**(DRAFT)**

13 Mar 2019

**Quarry (Mota Ulun)**  
**Environmental Impact Statement (DRAFT)**

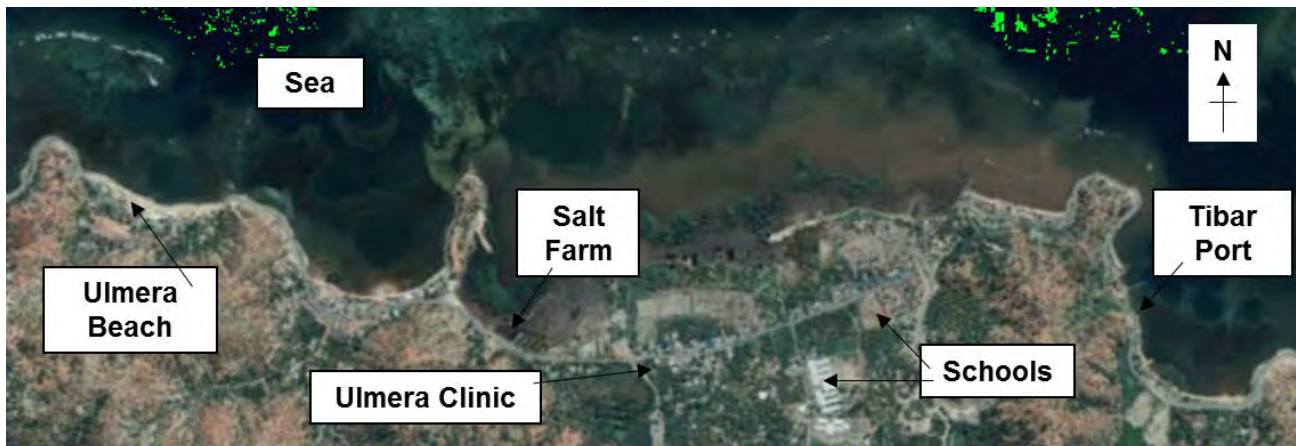
**Figure 4-4C. Entities in the Study Area (Part 3)**

- 4.6.3.5 The nearest Clinics are at Ulmera and at Liquica.
- 4.6.4 From the quarry to Tibar Bay, quarry dump trucks travel along the good condition Dili-Liquica trunk road. This approximately 11 km stretch of road is included in the study area (illustrated at Figures 4-4B and 4-4C), as part of transboundary effects, and traffic safety surveys are conducted.

- 4.6.6 Trucks deliver rocks and gravel from the quarry to Tibar Bay, and return for further loading and subsequent unloading. The road used is the Dili-Liquica truck road. The main impact on the entities on both sides of the 11 km stretch of road (illustrated at Figures 4-4B and 4-4C) is therefore due to heavy vehicle traffic.

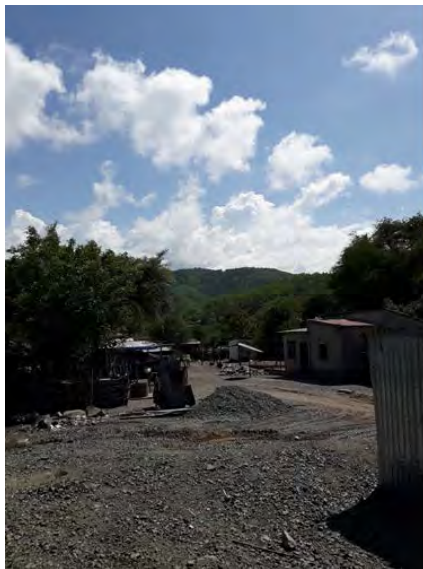
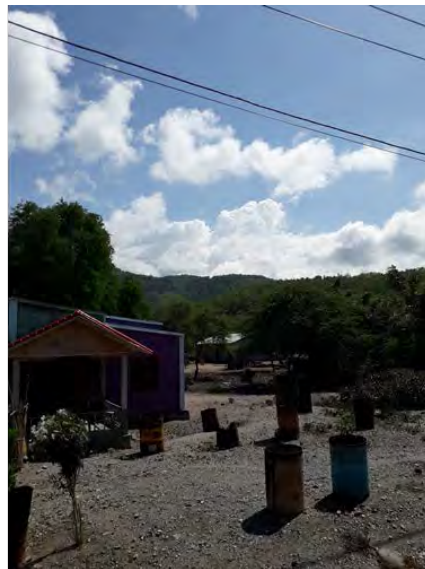
**Figures 4-7A and 4-7B. Views of the Quarry Hills from the Main Road**

- 4.6.8 The quarry hills, about 200m in height, are located about 1.5 km from the main Dili-Liquica road. Persons using this road are not able to have clear views of the lower parts of the hills because of obstructions caused by trees and other higher land features at the sides of the road, as shown at Figures 4-7A and 4-7B. The top of each hill will not be cut. At the end of rock extraction work, a “stepped pyramid (i.e. similar to rice terraces)” structure remains, with a trekking path winding-up to the original height of the hill. Such a feature has potential to be an amazing sight.

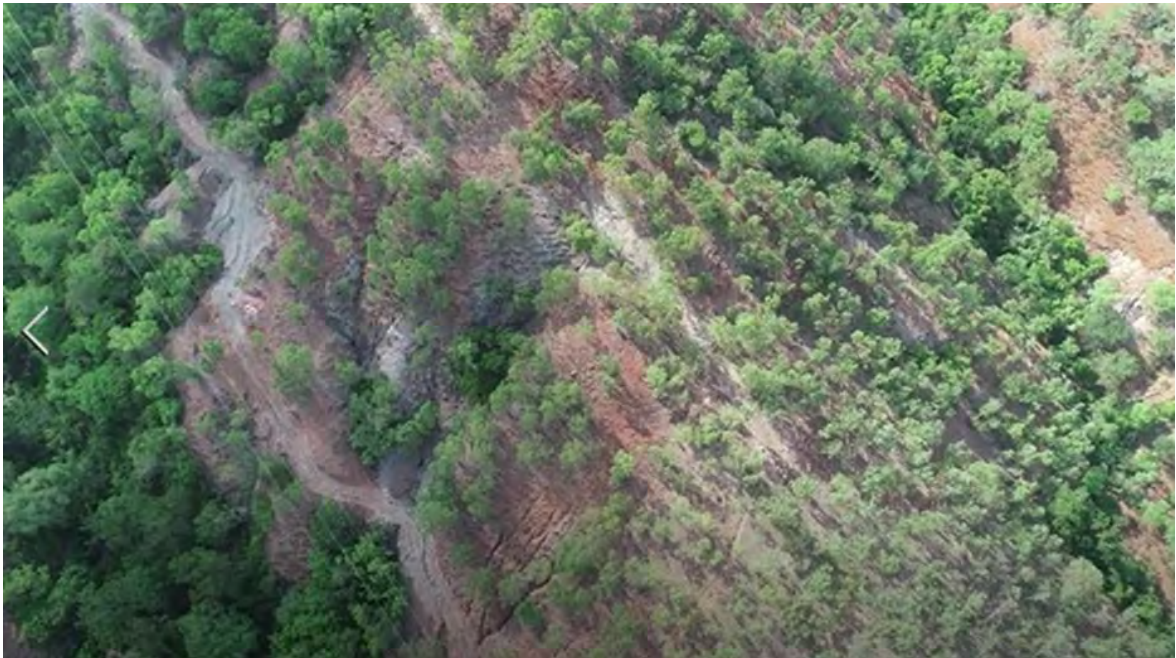
**Figure 6A-1 Top View of Hill A**

- 6A.2.1     Timor-Leste is in the Indonesia archipelago, an earthquake zone. Figures 6A-1 and 6A-2 show the general terrain where the quarry is located. It is in a hilly region, with hills about 200 m high at the most. . To the north, is the sea about 1,500 m away from the quarry hills. The beach is less than 8 m wide at high tide. . Bordering the beach is a good condition bitumen road with one lane each for traffic going in both directions.
- 6A.2.2     From the road to the land side, there is usually about less than 200 m of flat land before the rise of the hills. Figures 6A-1 and 6A-2 shows the top views of Hills A and B respectively. Attachment F has photographs showing other features of the terrain.

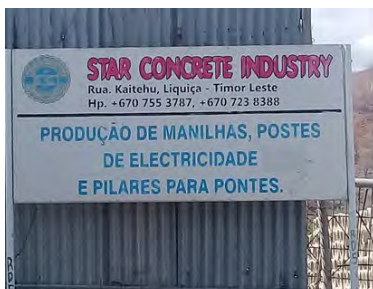
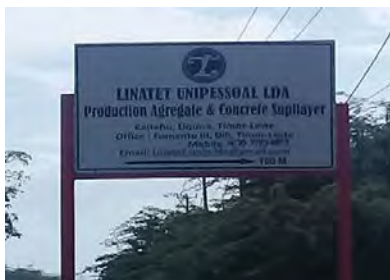
**Figure 6A-3. Existing Neighbouring Quarries**

6A.3.1 The location has no commercial rearing of livestock, or cultivation of crops, i.e. no air pollution due to animal waste or spraying of insecticides. Traffic along the main road is light. The existing 3 quarries and concrete part manufacturers (with name plates at Figure 6A-3), at the immediate west of the turn-off from the main road to the CHT Project site, are the main contributors to dust pollution.

- 6C.4.1 There is no tourism industry. The few occasional persons at the beachside are from the local community. There are 3 companies operating quarries and concrete works, of which pictures of name plates are shown at Figure 6A-3, at paragraph 6A.3.1. Opposite the road from the Project site is Laiara Bulk Fuel Station (sign board at Figure 6C-12). The arrival of the CHT quarry does not upset the existing industrial arrangement, or change the operating environment.

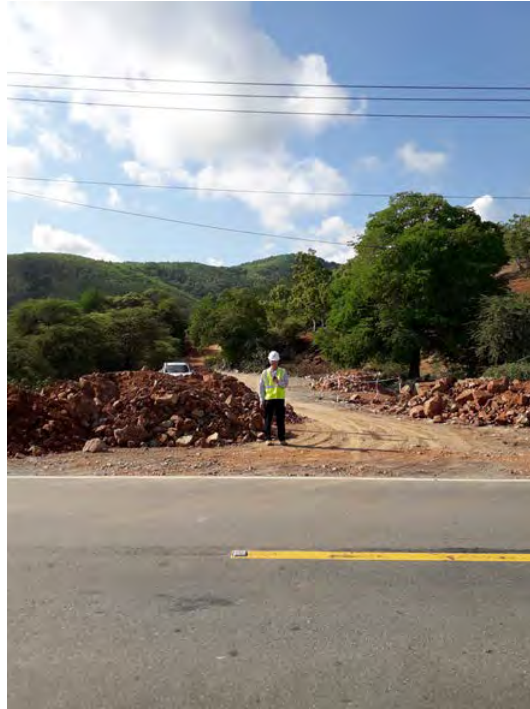
**Figure 6A-4. Location of Noise Sampling**

<b>SN</b>	<b>Vehicle</b>	<b>Reading (dBA)</b>
1	Ambient	62
2	Motorcycles / Sedans	72 to 78
3	Trucks	83

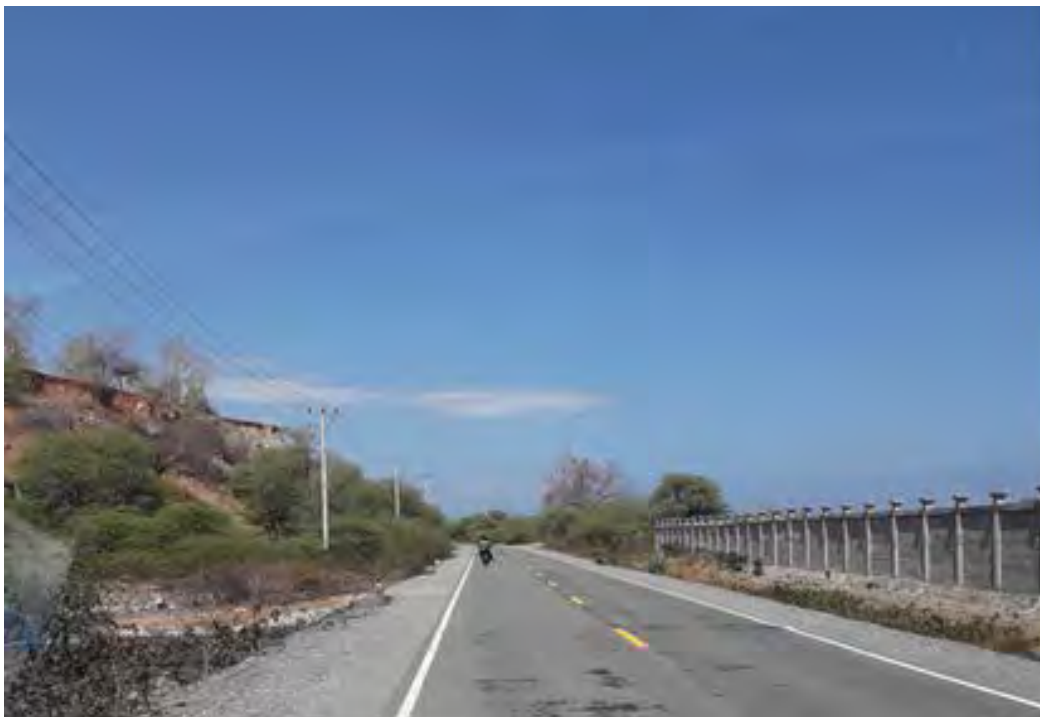
**Figure 6C-3. Illustration of Road Condition**

- 6C.2.1 The Dili-Liquica road varies in condition. However, the stretch passing through Mota Ulun, and from the Project site to Tibar Bay, is a good condition bitumen road, with one-lane traffic either way (illustrated at Figure 6C-3). There are run-offs with gravel at the sides of the road. There are no breakdown lanes or street lights.

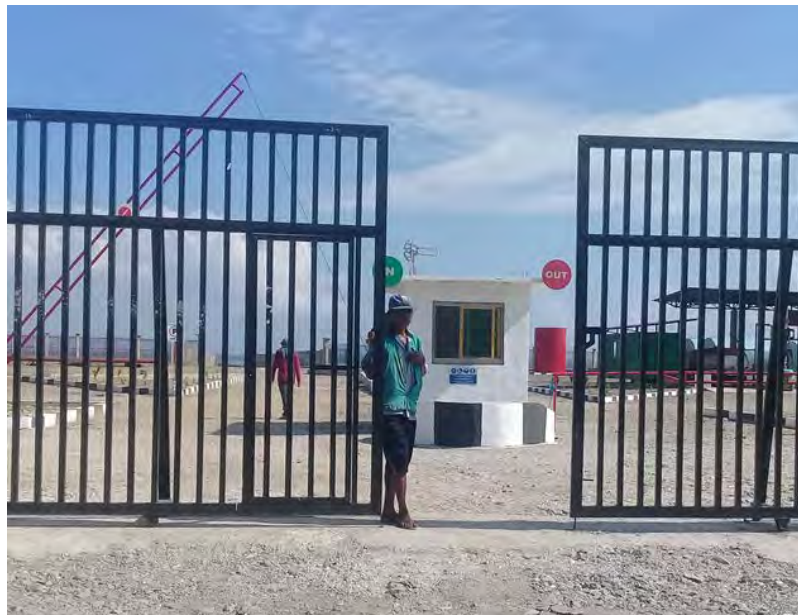
**Figure 6C-6. Entrance of Laiara Bulk Fuel Station**

- 6C.3.1 The existing industries are 3 small scale quarries with stone and concrete works (described at paragraph 6A.3.1), and Laiara Bulk Fuel Station (entrance shown at Figure 6C-6) with a jetty that is suitable for pipelines, but not usable by trucks, i.e. not designed as such.

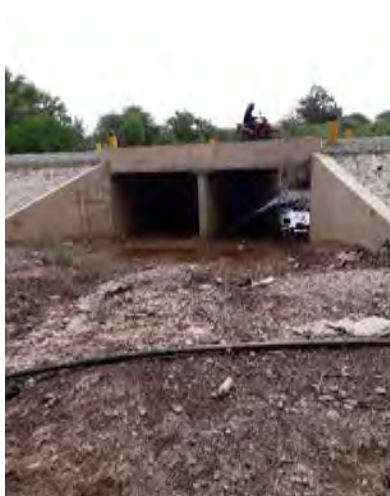
**Figure G1-2. Start Point. Inlet of culvert under crossing**  
**(of Dili-Liquica road)**

13. Observations along the route are shown at below. The distances stated in the figures are a continuation of distance for the Team, as it moves along, i.e. starting from the under-the-road culvert point. The distances are not distances from any other point.

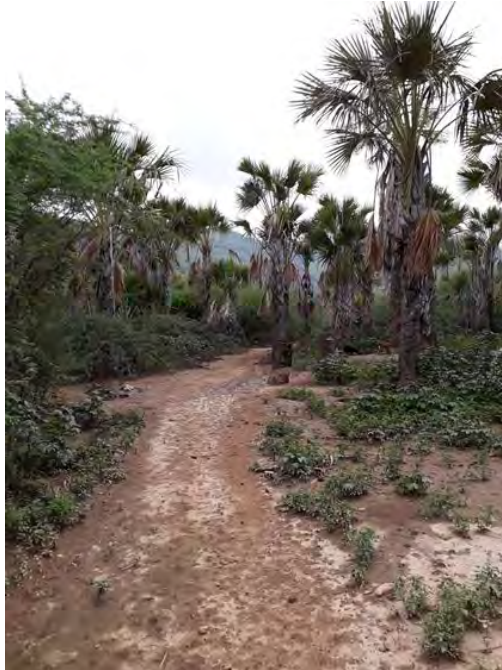
**Figure G1-9. 500 m. Dried-up drainage. Typical of terrain**

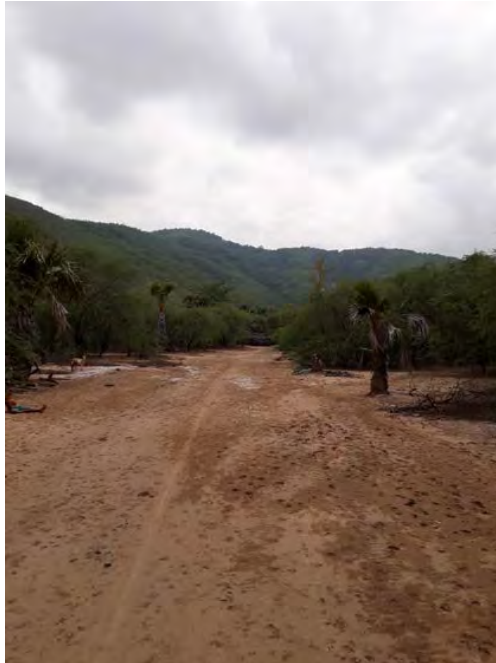
**Figure G1-11. 800 m. Further continuation of dried-up drainage.**  
**Note the wide ground span covered by water when it rains**

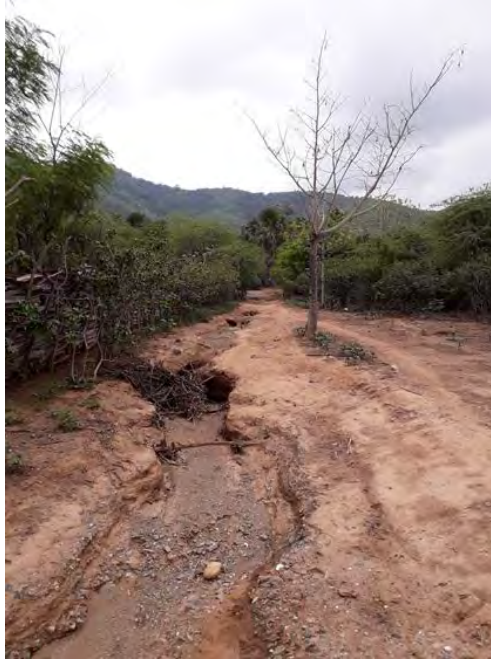
**Figure G1-13. 1,150 m. Rain water flow cutting a groove in the bed.  
(about 1 m wide, 30 m long and 30 cm deep)**

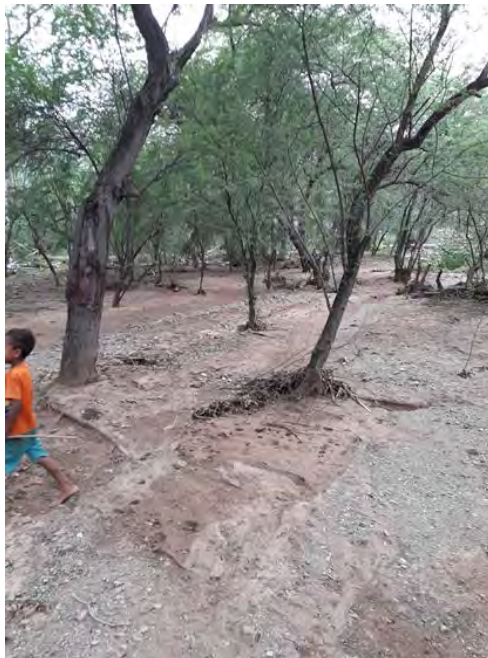
**Figure G1-20. 1,600 m. Wide area covered by rain water flow**

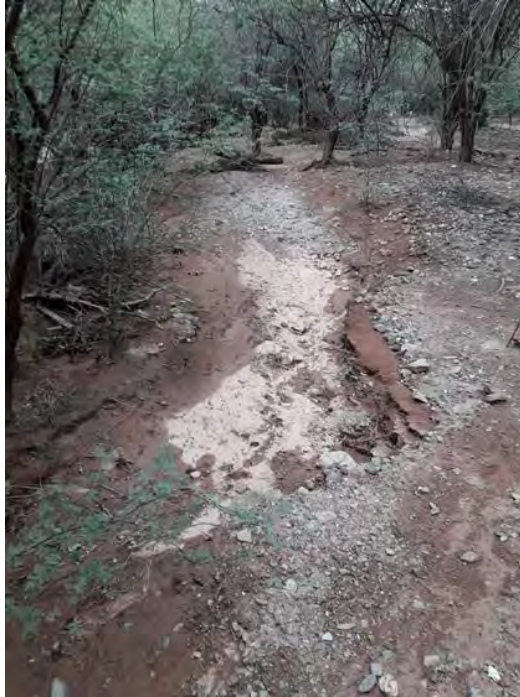
**Figure G1-21. 1,700 m. Depression (1 m wide by 3 m long by 20 cm deep), created by rain water flow**

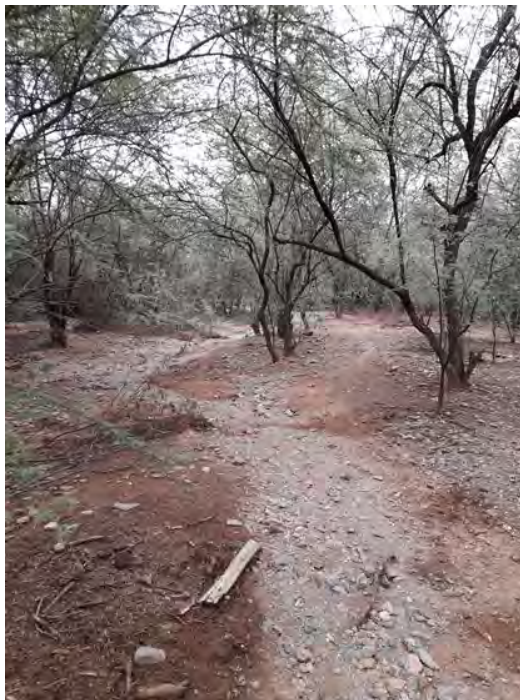
**Figure G1-22. 1,800 m. Wide area flooded by rain water**

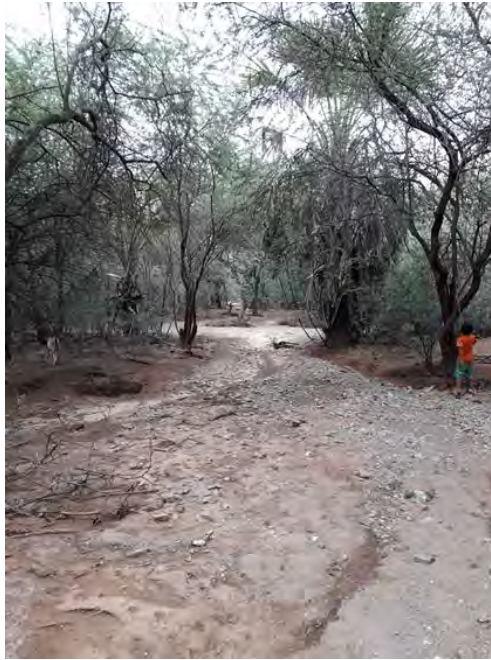
**Figure G1-23. 1,850 m. Continuation of wide area flooded by rain water  
(Note the stones on the ground)**

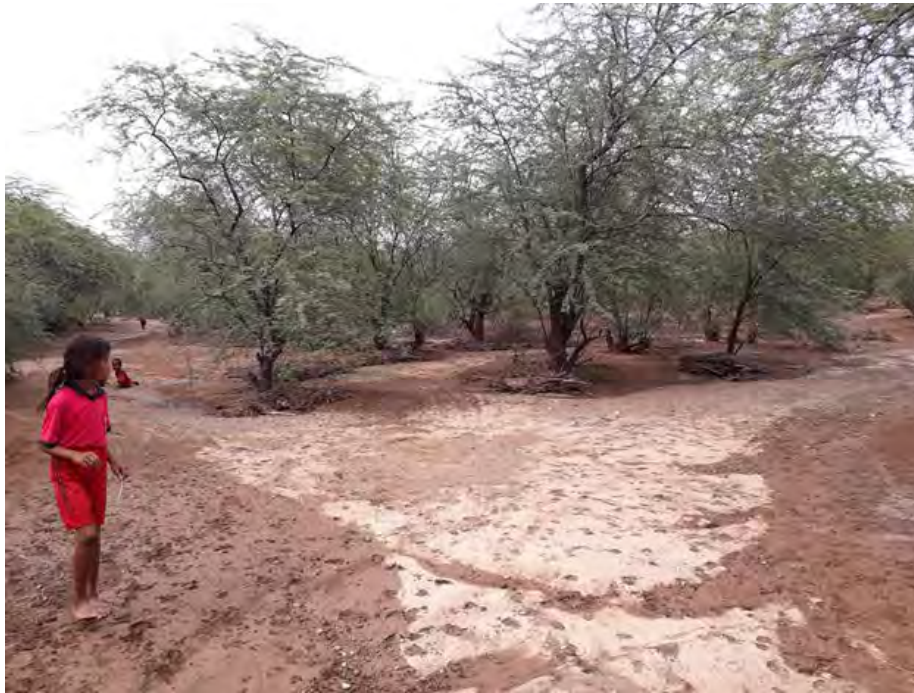
**Figure G1-25. 1,900 m. Wide area flooded by rain water**

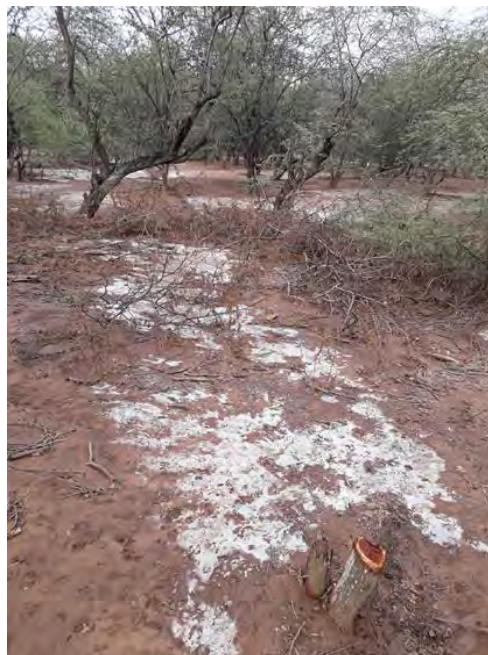
**Figure G1-26. 2,000 m. Another view of wide area flooded by rain water. Note thin white deposit on surface, and tree cut by villagers (truck stump remaining)**

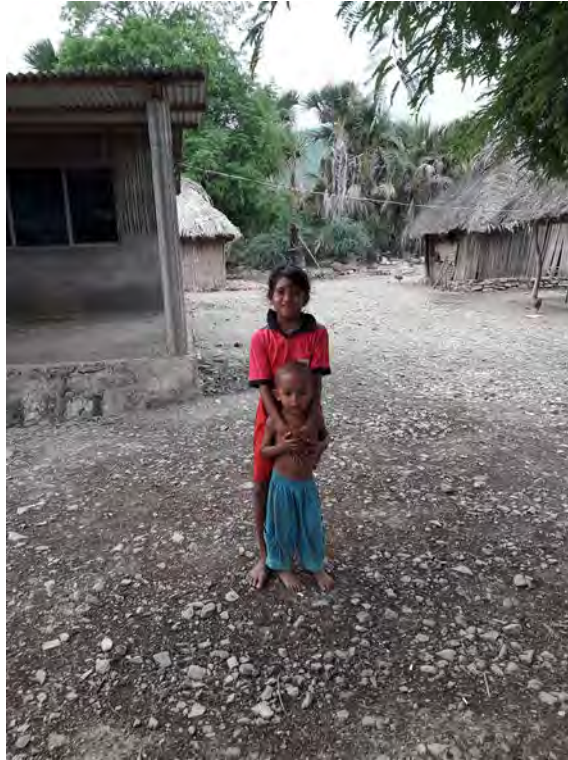
**Figure G1-27. 2,200 m. Return to village houses  
at location where culvert runs under the main road  
(Note the small stones on the ground carried down by the rain water)**

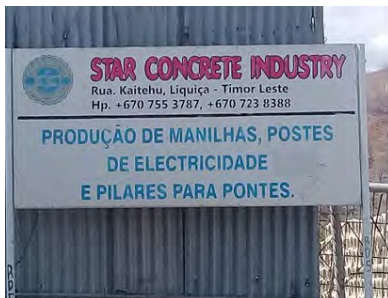
**Figure 2. Quarry Site Layout**

1. The China Harbour Timor Lda (CHT) quarry is at Mota Ulun, about 25 km west of Dili. A drawing showing the quarry and the surroundings is at Figure 1. The layout plan of the quarry is at Figure 2.
2. The stone processing yard, and the hills where blasting takes place, are about 1 km and 1.5 km respectively from the main road. The nearest local residences, located at the east of the main entrance, is about 1.5 m away from the stone processing yard.
3. There are 3 existing quarries, with excavation of rocks, making gravel and casting concrete parts, located 100 m west of the CHT quarry entrance at the main road. The name plates of these quarries are at Figure 3. The impacts of these dust generating sources are to be considered when conducting evaluations during CHT quarry operations. Evaluations for cumulative impacts might be difficult for these are quarries belong to the competition.

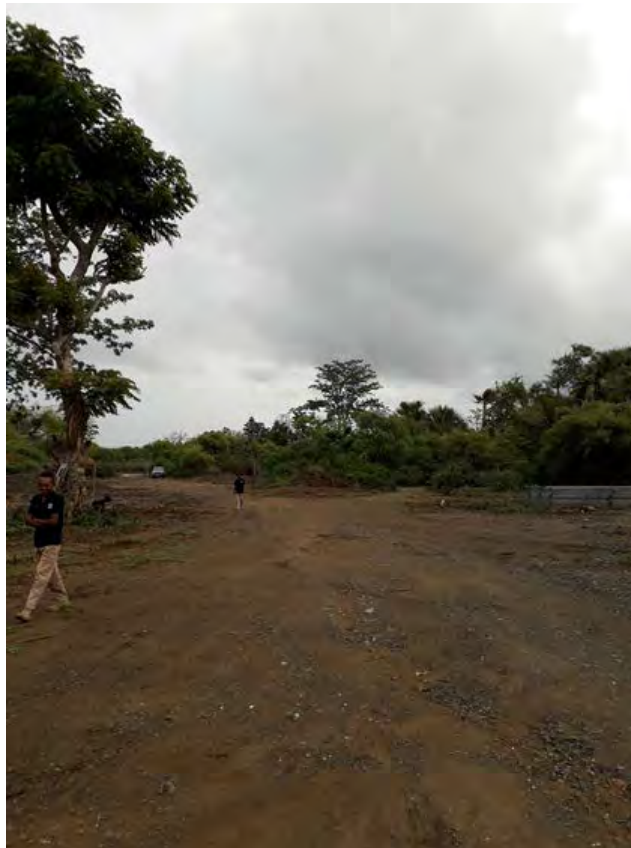
**Figure 4. Looking north from laydown area towards haul road to main road**

10. For a quarry, dust is invariably carried by wind to receptors further away. The terrain at the CHT quarry is favourable for containing dust, e.g. quicker settlement and capture, as against blown further away. The reasons are high hill formations and a thick line of tall trees and shrubs surrounding the rock and gravel processing and storage areas, as shown at Figures 4 to 8. The vegetation continues until the nearest residential properties about 1.5 km away. These features have the effect of reducing the strength of the wind, and containing dust.

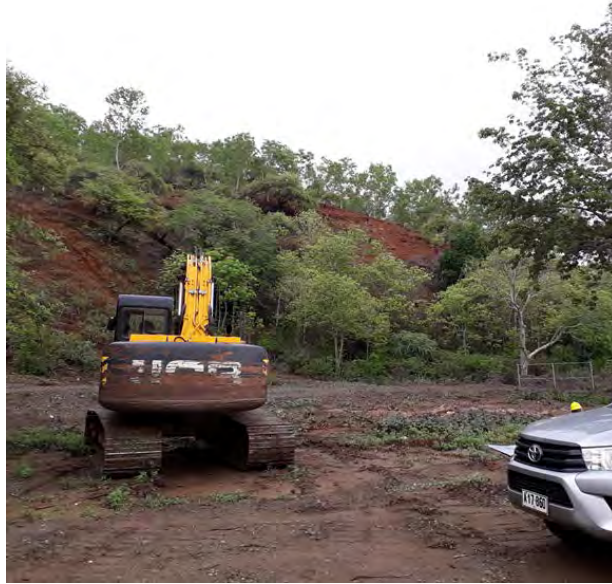
**Figure 5. Hills at north-west side of laydown area**

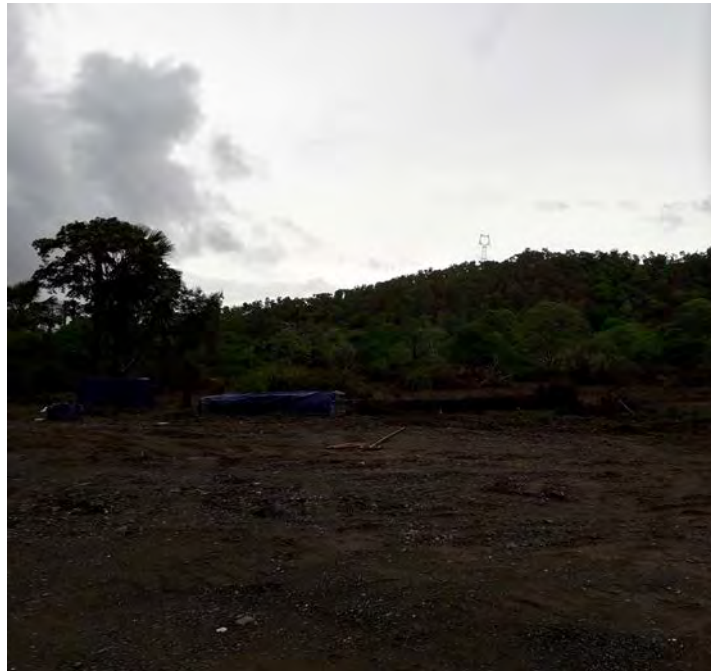
**Figure 6. Hills at west side of laydown area**

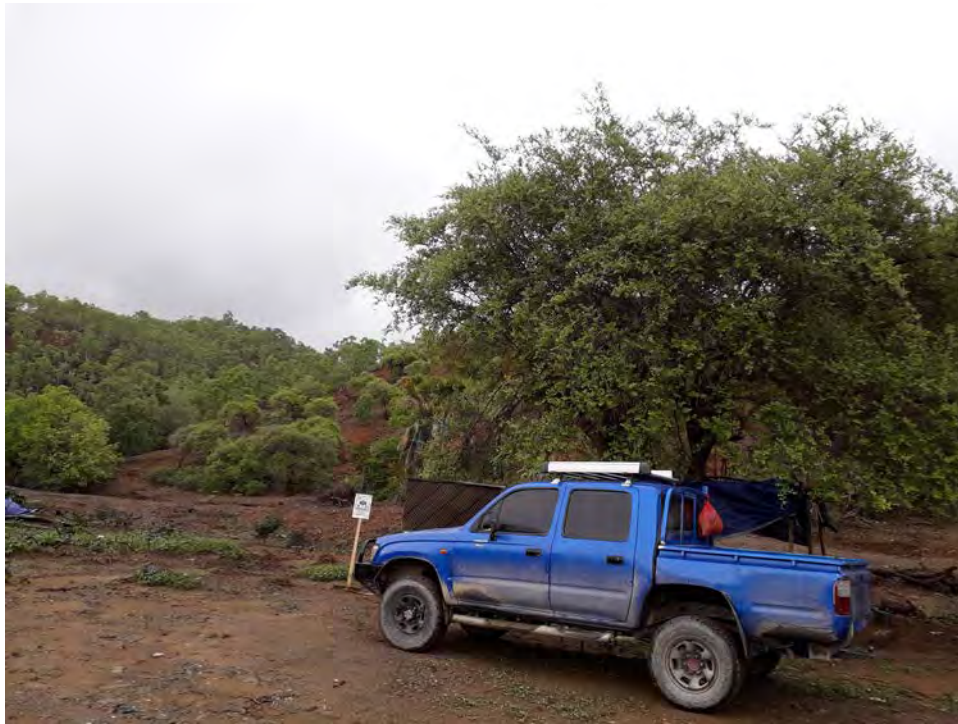
**Figure 7. Another view of hills and vegetation at west side of laydown area**

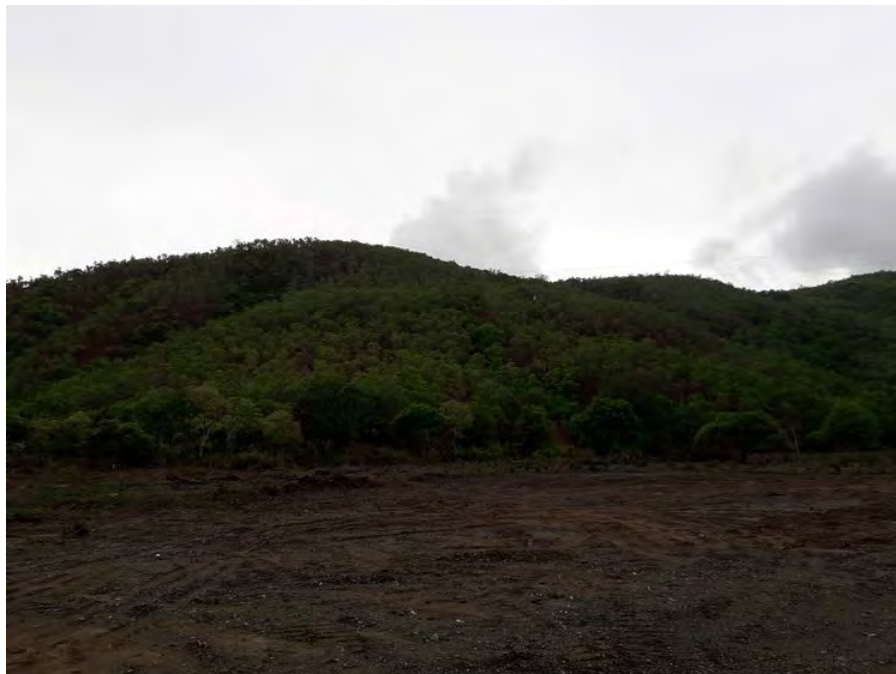
**Figure 8. Hills at east side of laydown area**

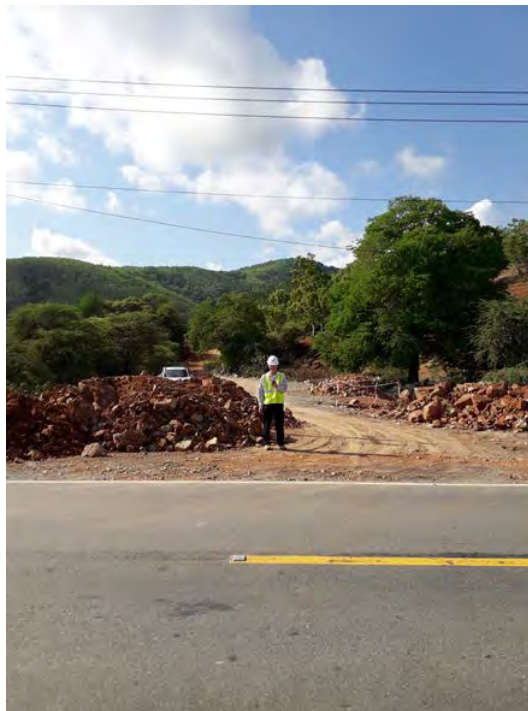
**Figure 1. Location of Noise Sampling**

<b>SN</b>	<b>Vehicle</b>	<b>Reading (dBA)</b>
1	Ambient	62
2	Motorcycles / Sedans	72 to 78
3	Trucks	83
